Able Inspections

Building Analysis Report

Inspection date: Wednesday, November 18, 2015

Structures inspected: Home

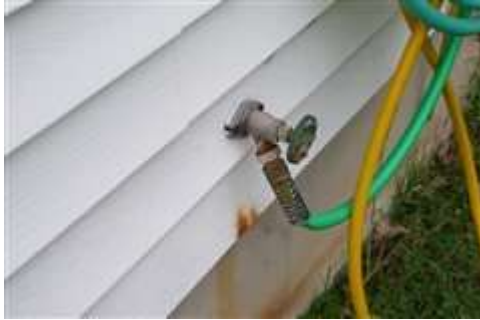
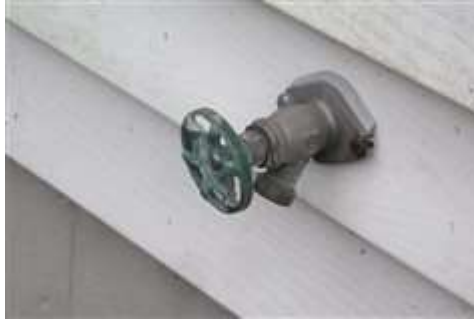
1) 🚰🔧 One or more outside faucets are missing [backflow prevention devices](#). These devices reduce the likelihood of polluted or contaminated water entering the potable water supply. This condition can occur when an outside faucet is left in the "on" position with a hose connected and the sprayer head turned off. When pressure in the system fluctuates, water can be drawn back into the water supply pipes from the house. If a chemical sprayer is being used with the hose, those chemicals can enter the water supply pipes.

Recommend installing backflow prevention devices on all exterior hose bibs where missing. They are available at most home improvement stores and are easily installed. For more information, visit: http://edis.ifas.ufl.edu/BODY_AE079

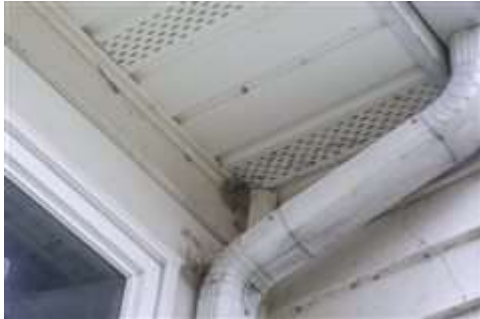
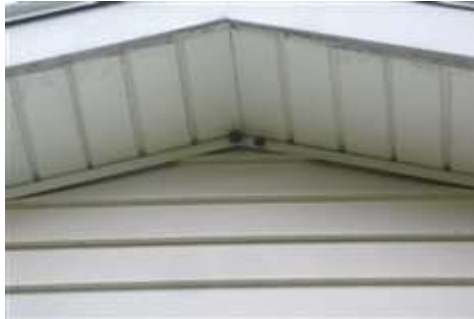
2) 🐝🔧 One or more hornet, bee and/or wasp nests were found. These can pose a safety hazard. Nest(s) should be removed as necessary.

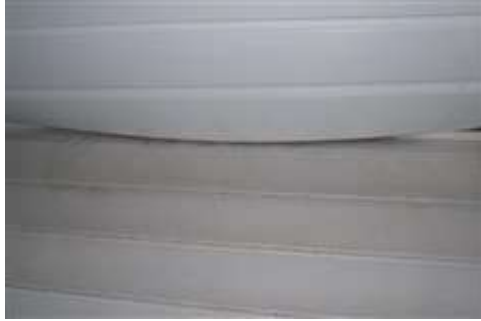
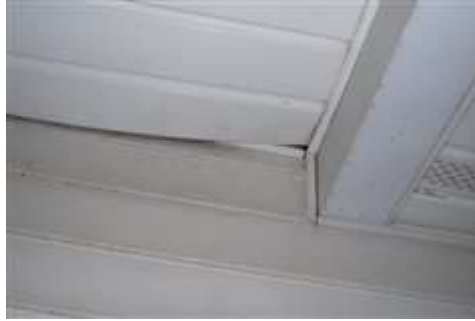
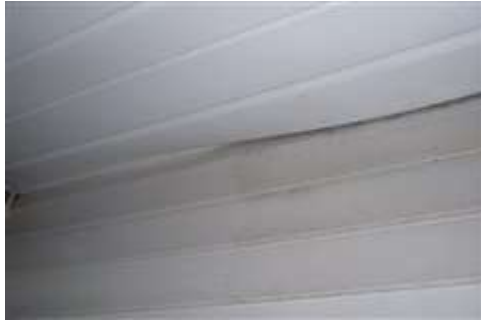
4) 🛠️ Gaps exist at one or more openings around the exterior, These gaps should be repaired to prevent birds and rodents from nesting

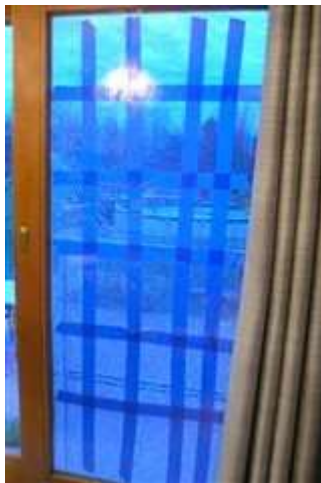
Photo 5-1

Rear door has shattered window recommend replacement

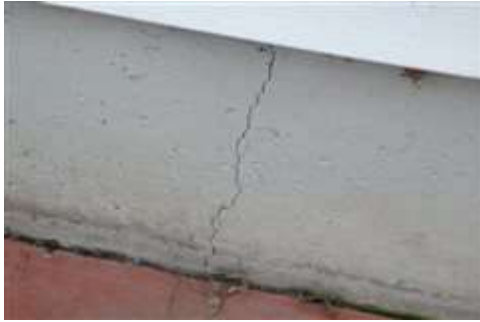
Photo 6-1

One or more minor cracks (1/8 inch or less) were found in the foundation. These don't appear to be a structural concern, but recommend sealing them to prevent water infiltration and monitoring them in the future. Numerous products exist to seal such cracks including:

- Hydraulic cement. Requires chiseling a channel in the crack to apply. See <http://www.quickrete.com/catalog/HydraulicWater-StopCement.html> for an example.
- Resilient caulks (easy to apply). See <http://www.quickrete.com/catalog/GrayConcreteRepair.html> for an example.

- Epoxy sealants (both a waterproof and structural repair). See <http://www.mountaingrout.com/> for examples of these products.

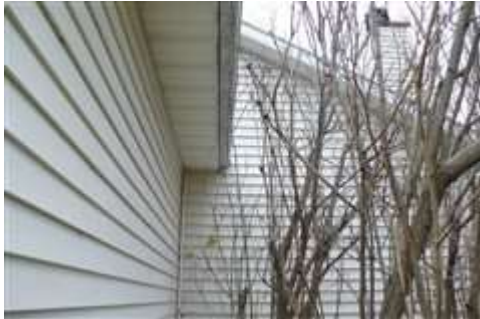
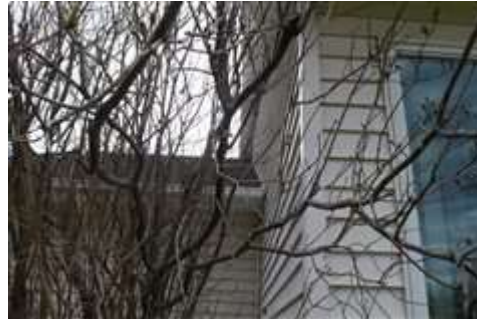
Vegetation such as trees, shrubs and/or vines are in contact with or less than one foot from the structure's exterior. Vegetation can serve as a conduit for wood destroying insects and may retain moisture against the exterior after it rains. Vegetation should be pruned and/or removed as necessary to maintain a one foot clearance between it and the structure's exterior.

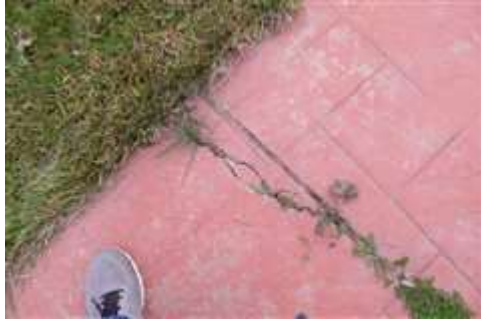
Photo 9-1

Minor cracks were found in one or more sidewalk or patio sections. However they don't appear to be a structural concern and no trip hazards were found. No immediate action is recommended, but the client(s) may wish to have repairs made or have cracked sections replaced for aesthetic reasons.

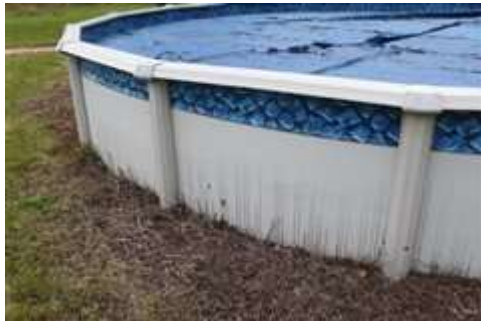
Photo 10-1

10) Height of swimming pool appears to be lower than New York State requirements. See above ground pool requirements at this hyper link
<http://www.dos.ny.gov/dcea/pdf/PoolsumUC0708.pdf>

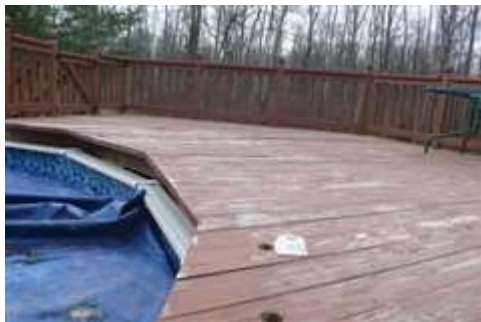
Photo 11-1

11) Pool deck is in need of refinishing

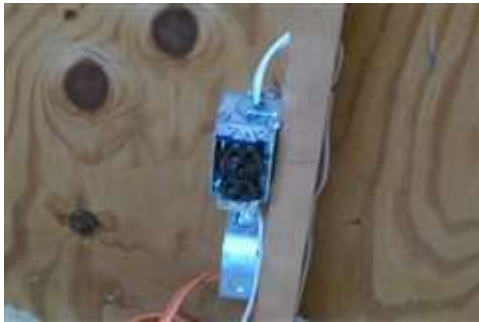
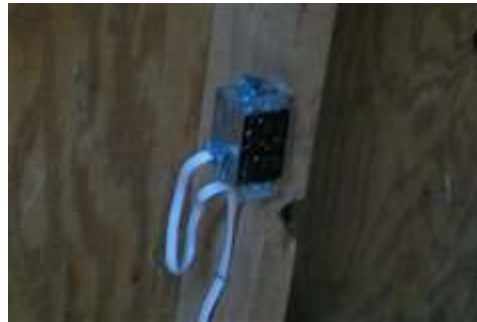
14) 🛠️👉 Cover plate(s) are missing from one or more electric boxes, such as for receptacles, switches and/or junction boxes. They are intended to contain fire and prevent electric shock from exposed wires. This is a safety hazard due to the risk of fire and shock. Cover plates should be installed where missing.

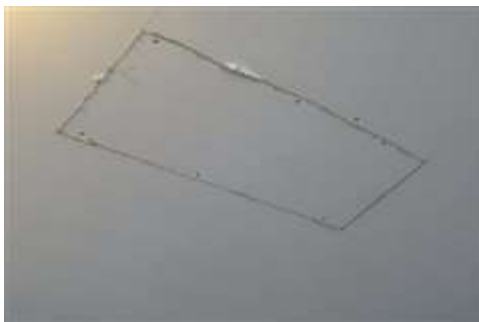
Photo 16-1

16) ⓘ Inspector recommends asking the home seller what the reason is for the patch cut in the garage ceiling

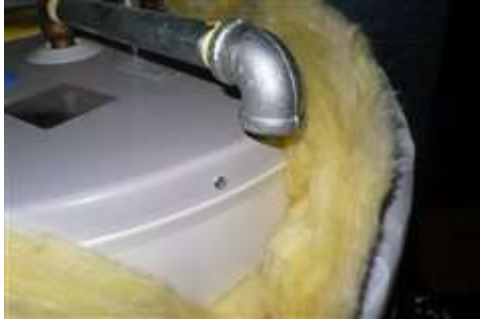
Photo 18-1

No drain line is installed for the temperature-pressure relief valve. This is a potential safety hazard due to the risk of scalding if someone is standing next to the water heater when the

valve opens. A qualified plumber should install a drain line as per standard building practices. For example, extending to 6 inches from the floor, or routed so as to drain outside.

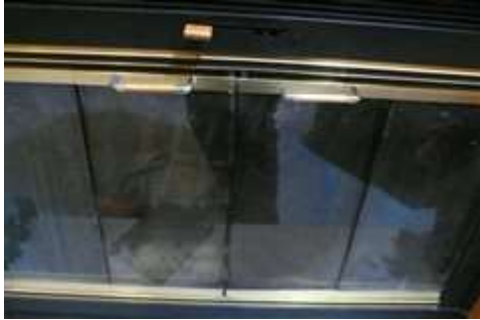
Photo 20-1

20) **i** All solid fuel burning appliances (woodstoves and fireplaces, etc.) should be inspected annually by a qualified chimney service contractor, cleaned and repaired as necessary.

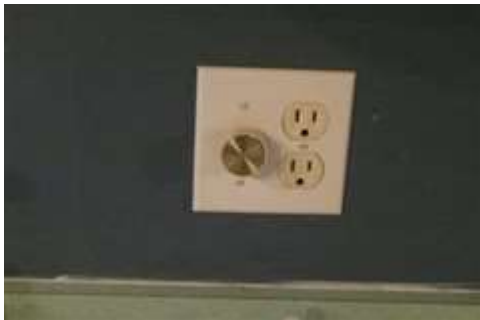
Photo 22-1

22) Dimmer switch is not functioning properly

Dimmer switch is not functioning

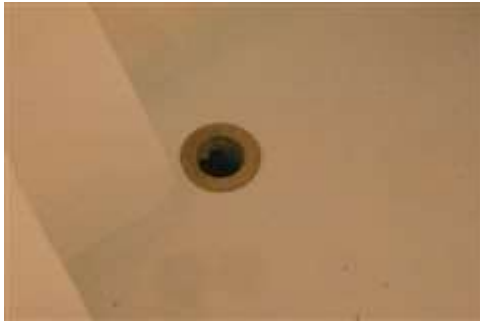
Photo 23-1

23) 🛠️ One or more bathtub drains are clogged or drain slowly. Drain(s) should be cleared as necessary, and by a qualified plumber if necessary.

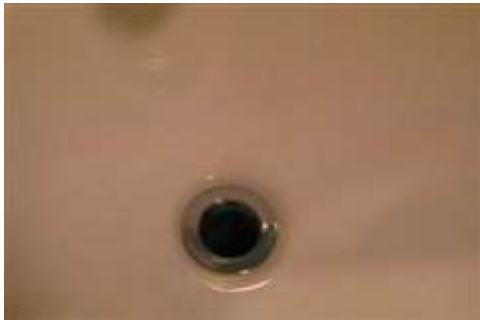
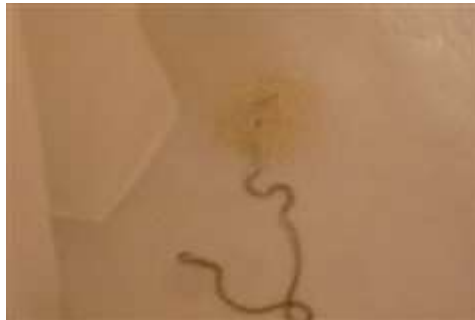
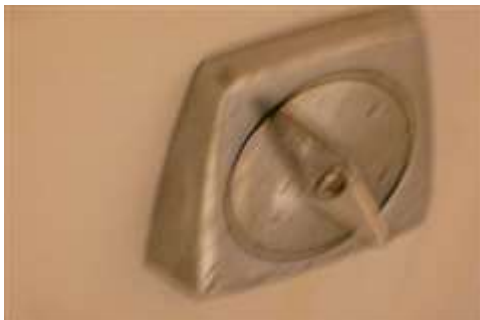
24) 🛠️ Sink in upstairs bathroom has no water stop

Jet tub off Master Bedroom has no drain stopper. mechanical water stop is not working

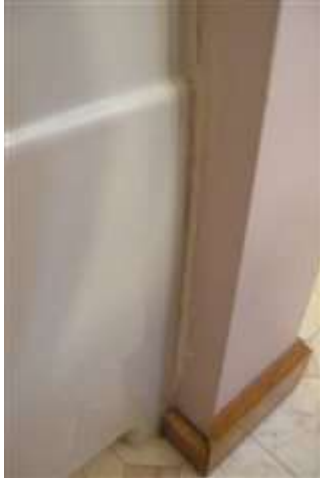
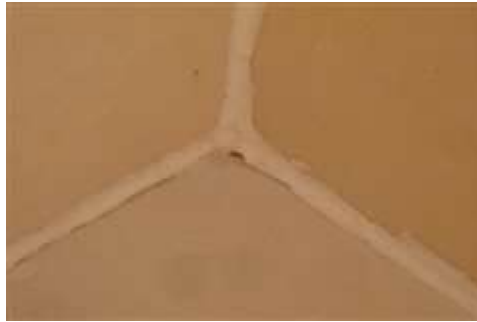
25) 🛠️💧 Caulk is missing or deteriorated above one or more bathtubs, where the tub surround meets the tub. It should be replaced where deteriorated and/or applied where missing to prevent water intrusion and damage to the wall structure.
